## OYRANOS (F/G)

## TECHNICAL SPECIFICATIONS – SHIP DATA

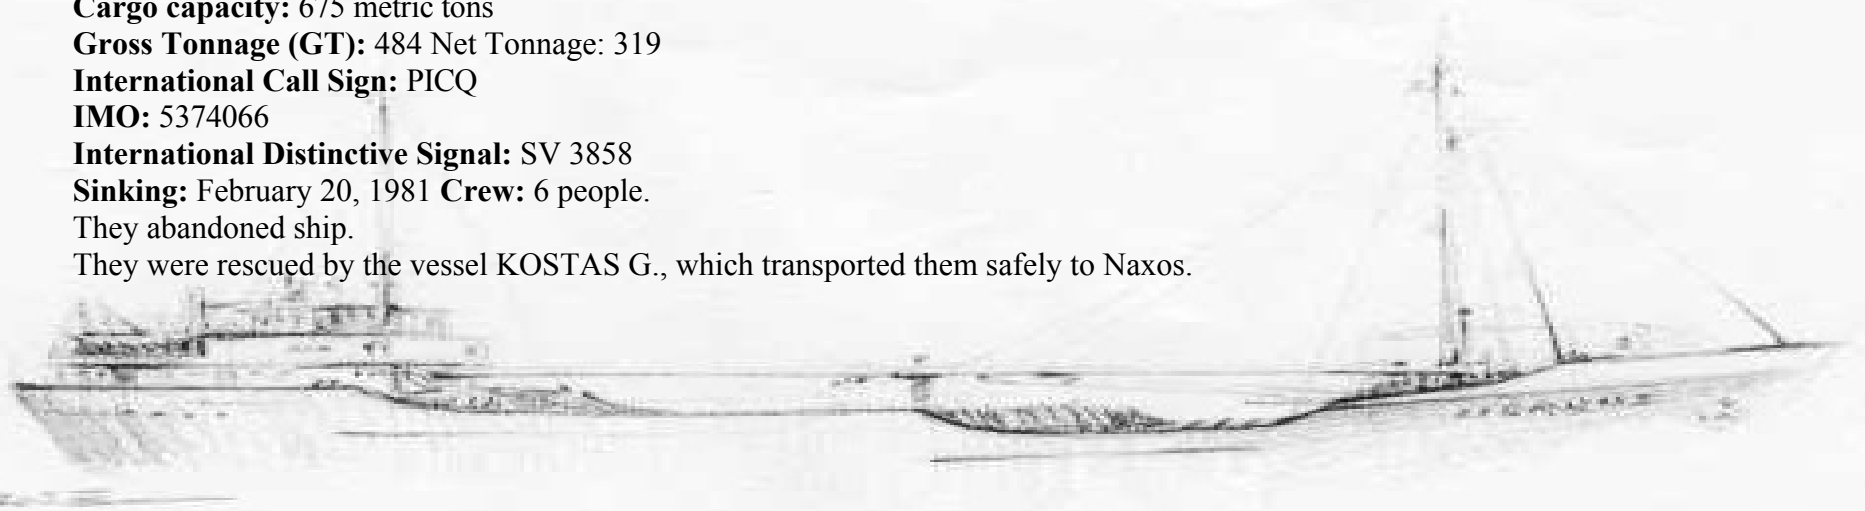
### ΑΚΥΒΕΡΝΗΤΟ ΜΙΚΡΟ ΦΟΡΤΗΓΟ ΚΟΝΤΑ ΣΤΗ ΝΑΞΟ

ΠΕΙΡΑΙΑΣ, 18.— Τὸ μικρὸ φορ-  
τηγὸ «Οὐρανός», 451 κόντων, ἐνῶ  
κατευθυνόταν ἀπὸ τὴν Χαλκίδα με-  
φορτίο τσιμέντου, στὴ Δωδεκάνησο,  
ἔμεινε ἀκυβέρνητο, λόγῳ μηχανικῆς  
βλάβης, ὀκτῶ μίλια βορειοανατολι-  
κὰ τῆς Νάξου. Τὸ πλήρωμά του, ἀ-  
πὸ πέντε Ἕλληνες καὶ ἓνα ξένο, ἐ-  
γκατέλειψε τὸ σκάφος καὶ παραλή-  
φθηκε σῶσο ἀπὸ τὸ διερχόμενο φορ-  
τηγὸ «Κώστας».

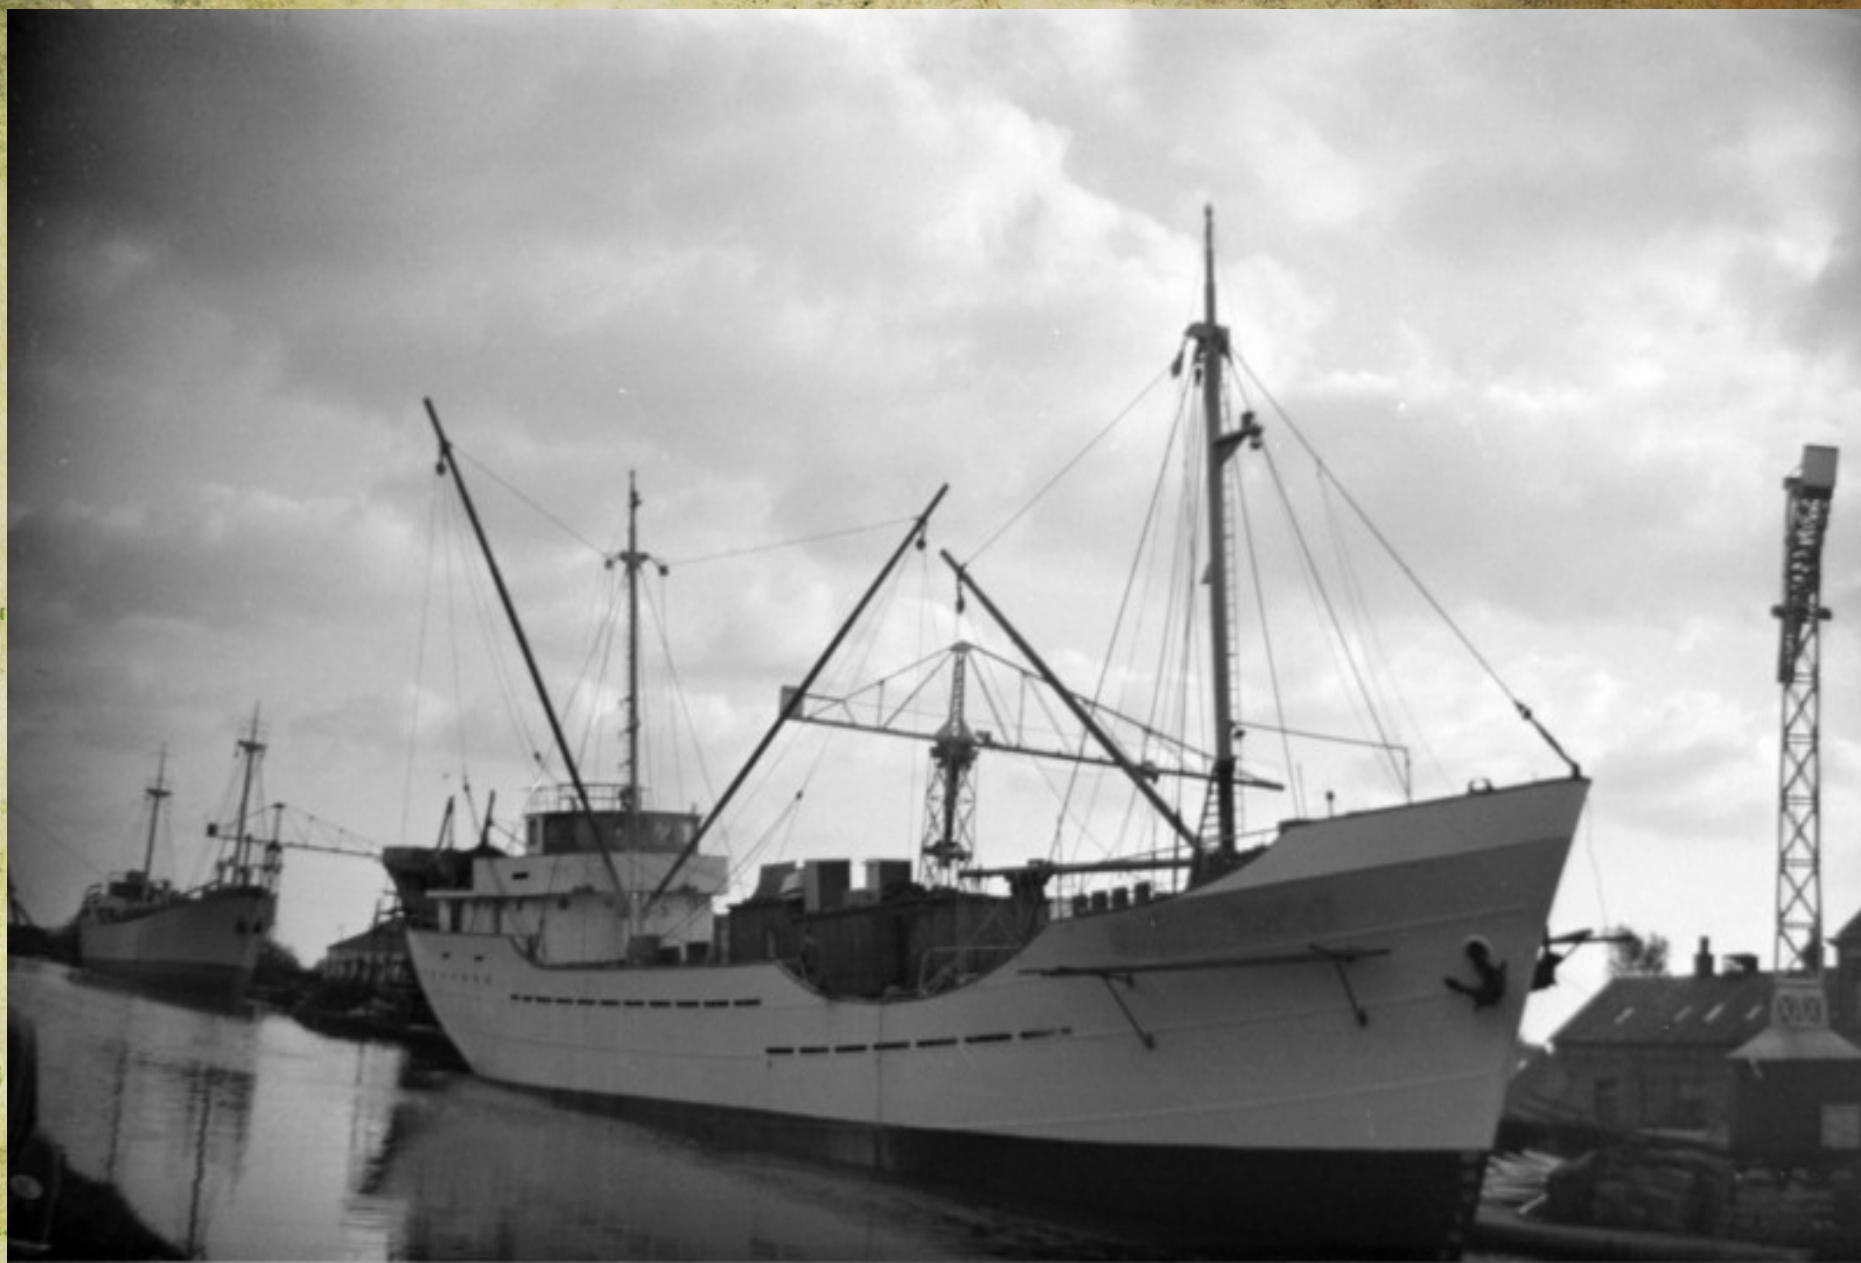
*The Uranus at Noord Nederlandse in Groningen, the Netherlands. 1952. (Collection, B.Th. Gernaat)*

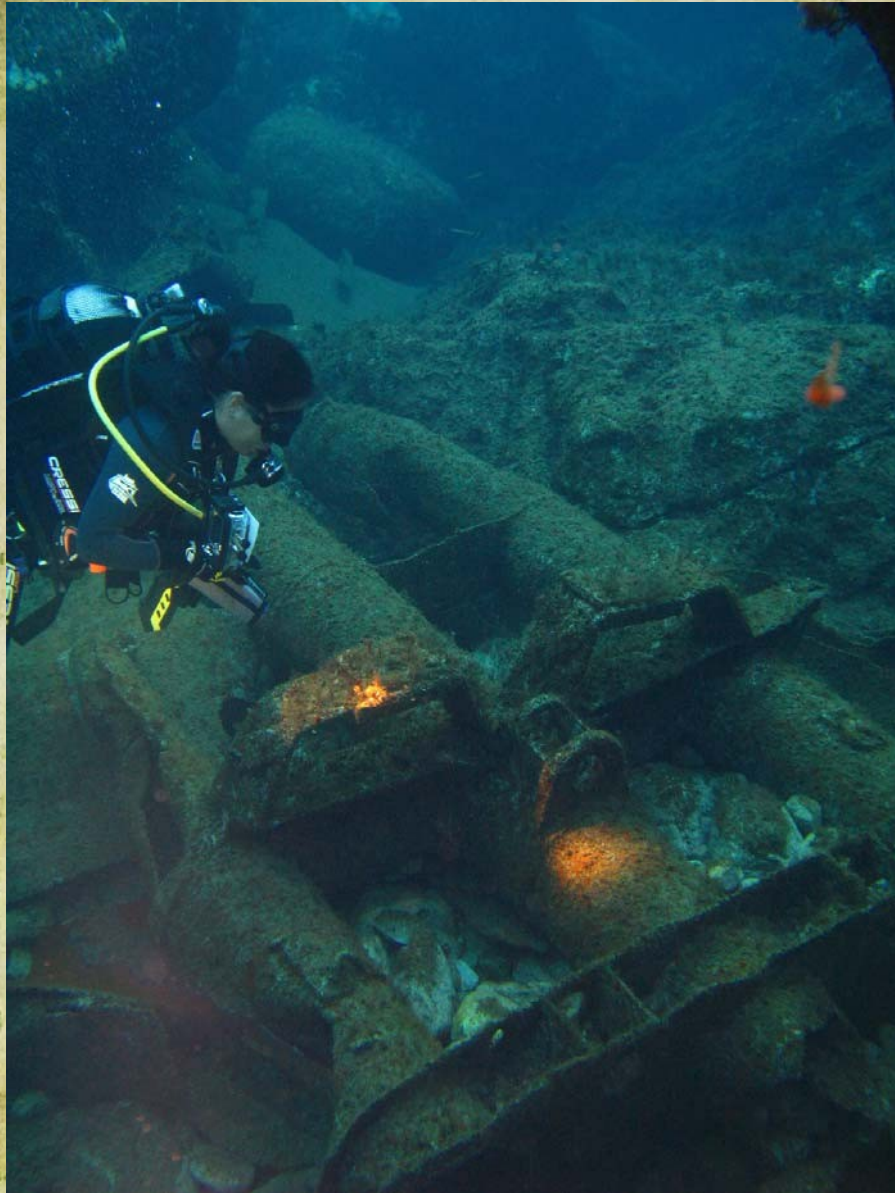
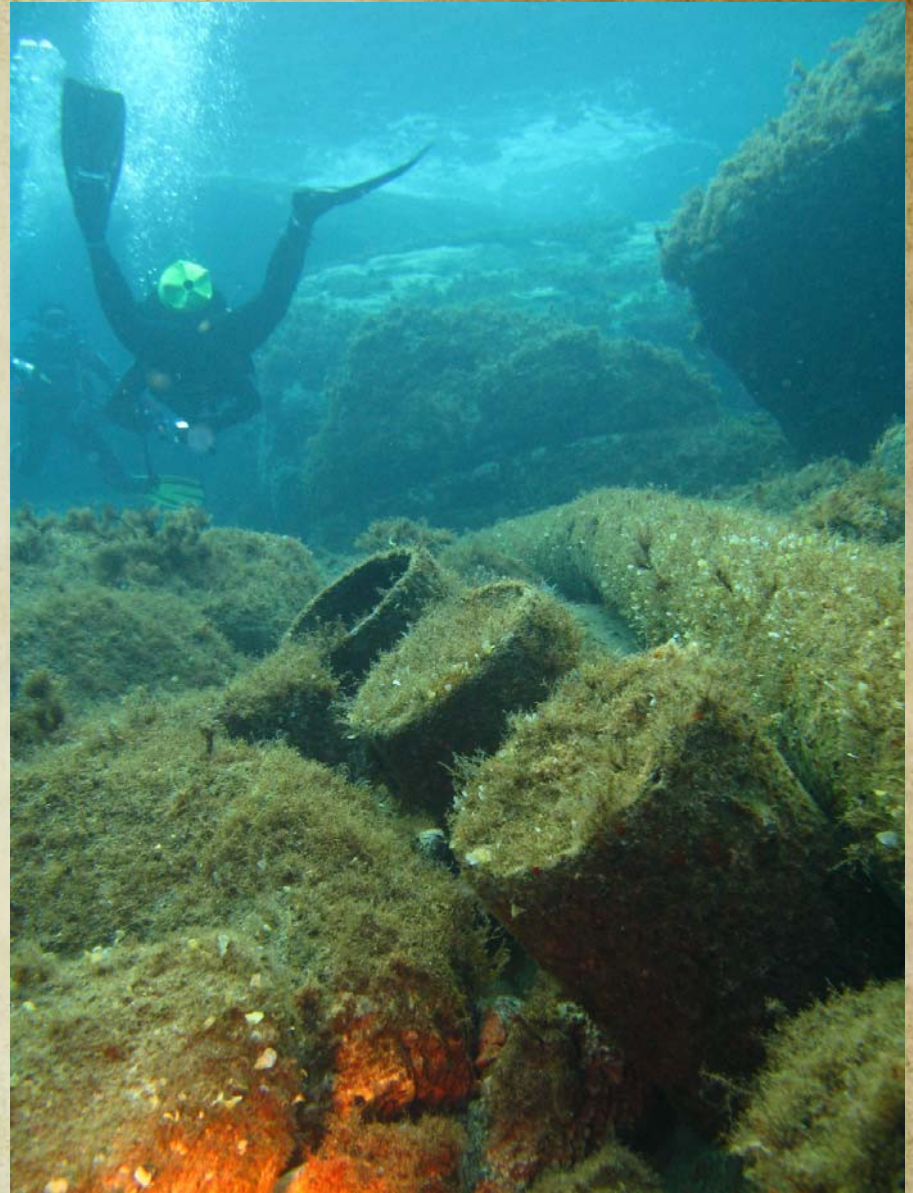
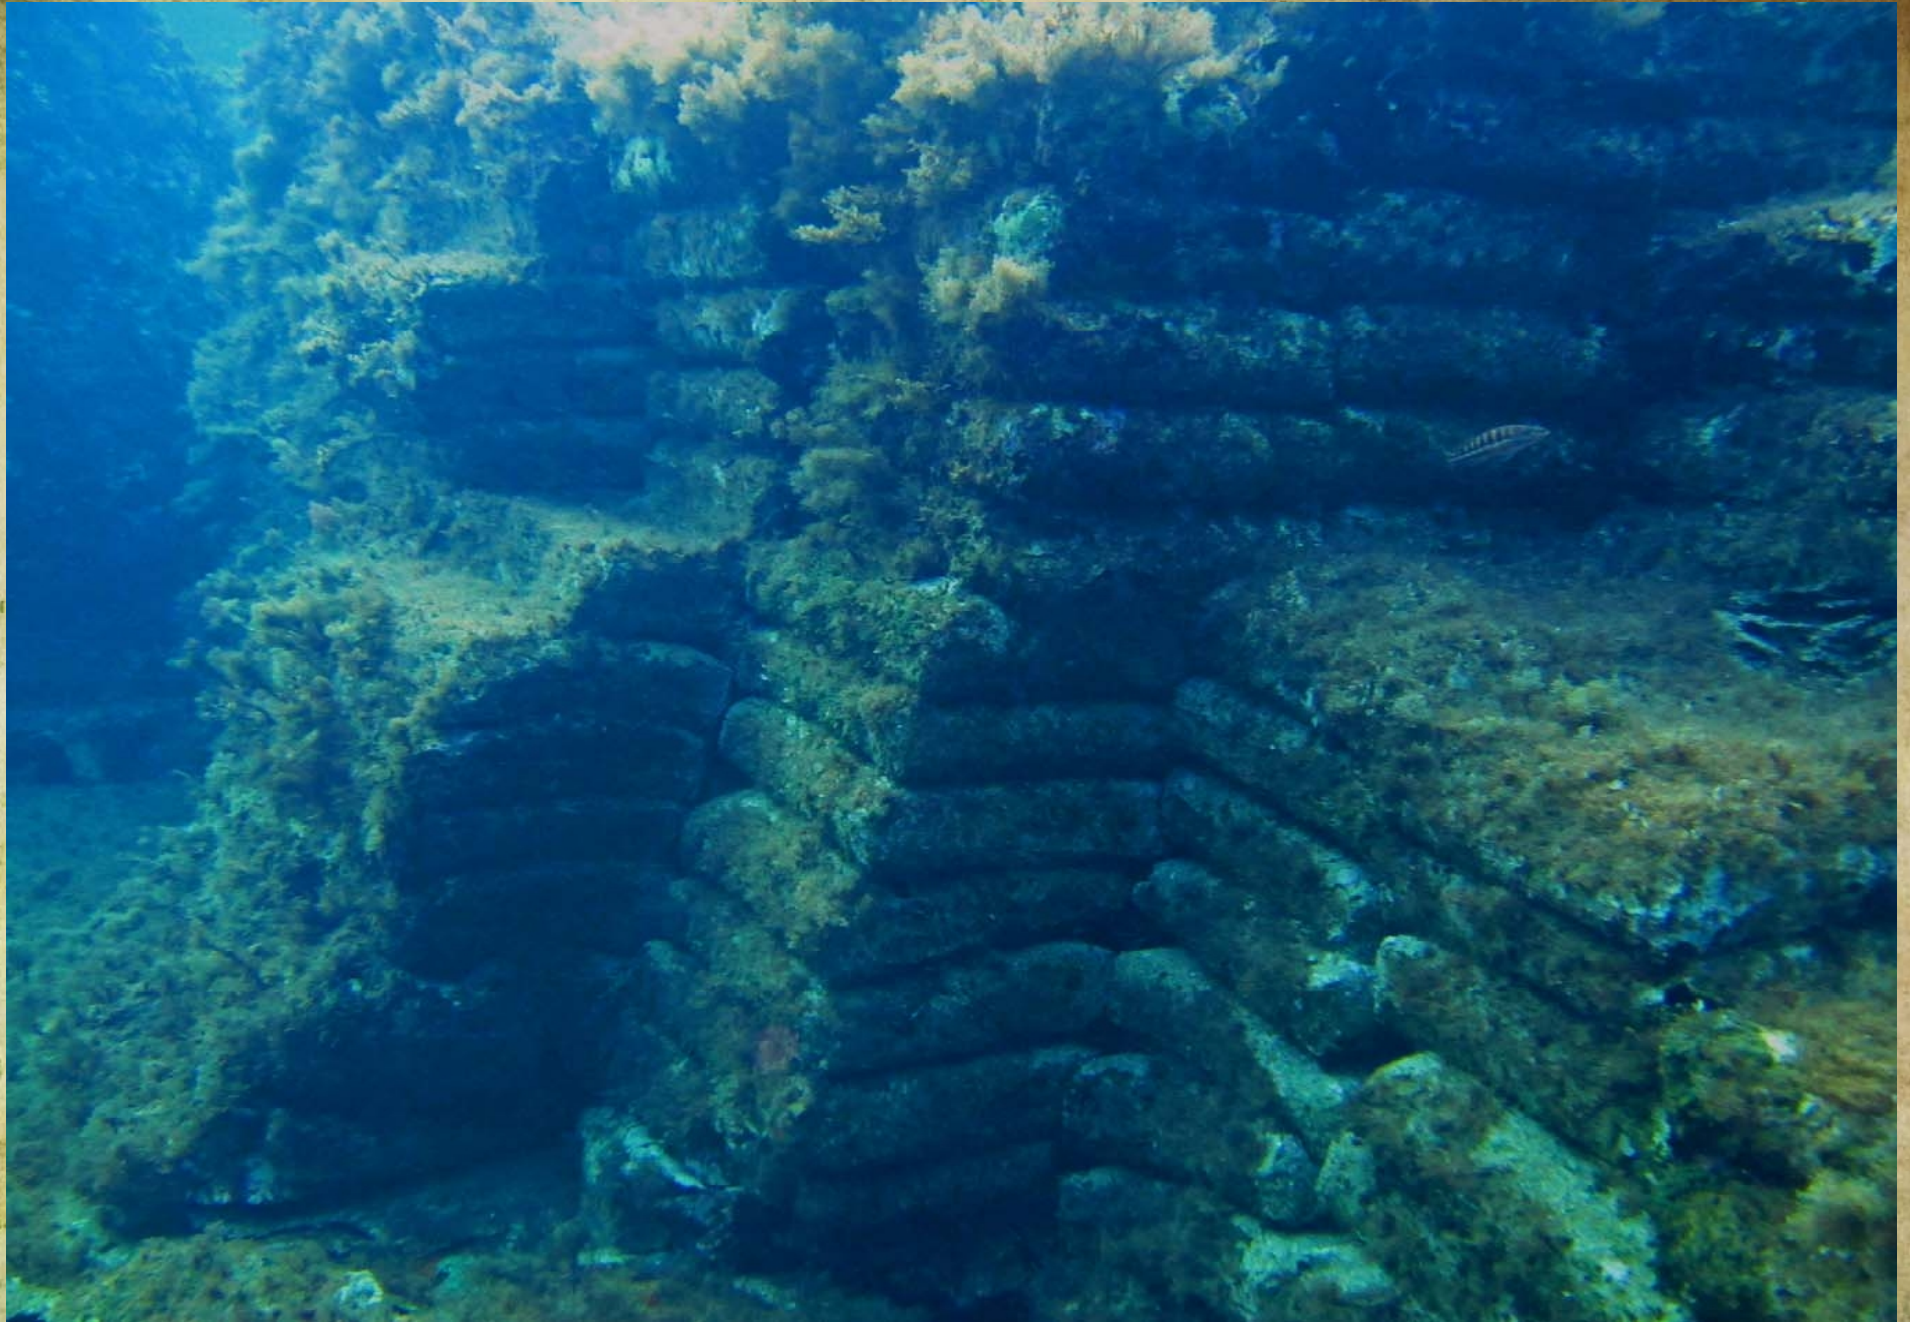
The frequent, strong northerly winds, the shallow depth of the wreck, and the rocky composition of the seabed have, over time, been significant factors in the wreck's collapse and near-complete disintegration. The largest remaining intact section is the cargo of hardened cement, which is still arranged in stacked pallets, along with the portion of the ship's hull that became trapped beneath them.

Large scattered pieces of sheet metal, large metal beams, and sections of the rigging are strewn throughout the area. Part of the bow lies at a depth of 30 meters, while the anchor chain stretches from the shallows to the deeper waters and disappears as it sinks into the sand, leading to the conclusion that before the ship was abandoned, the crew had dropped anchor to hold it in place and prevent it from running aground on the rocks.
